Pentium® II Xeon™ Processor Specification Update

Release Date: August 1998

Order Number: 243776-004

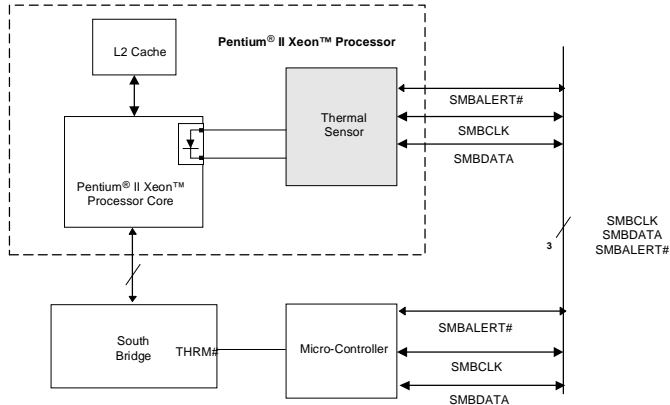
Figure 1. An Example of Microcontroller Driven Thermal Management

30. Thermal Sensor May Assert SMBALERT# Incorrectly

PROBLEM: The Pentium II Xeon processor has a thermal sensor that monitors the processor core's temperature. The thermal sensor asserts SMBALERT# if the processor temperature exceeds the temperature limits set in the Alarm Threshold Registers (T_{HIGH} , T_{LOW}). It also sets the corresponding Status Register bits to identify the cause of the interrupt. Figure 1 gives one example of the how the SMBALERT# signal could be used in a system.

Under the conditions described below, the thermal sensor incorrectly generates the SMBALERT# interrupt. *All* of the following conditions must be met to trigger a false interrupt:
